## 252 Atlantic Street

### Activity Report for the Period Ending May 31, 2023

#### **Structural Issues**

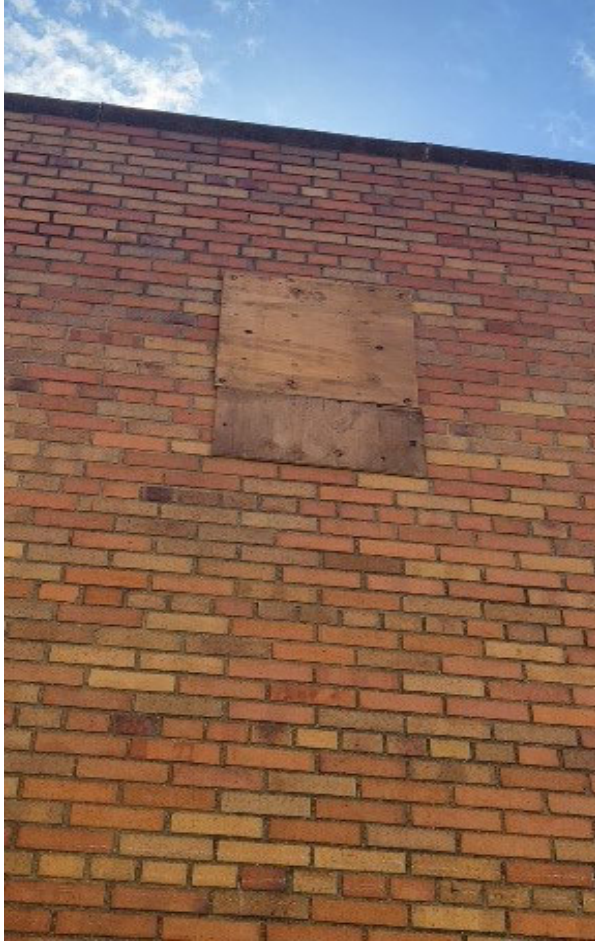
**Figure 1 – Exterior Wall Demolition**

The construction team then began a more focused evaluation of the overall structural integrity of the building by exposing the perimeter steel beams and columns encased in the masonry walls throughout the building. Figures 1 and 2 on the following page illustrate the work effort. We simultaneously solicited proposals from steel contractors to remediate the problems identified. However, these efforts proved premature as a more extensive investigation led to the identification of additional problems.

Once we were able to open the exterior walls, we learned that while the structural steel was painted prior to installation, no other flashing, waterproofing, or moisture protection was provided. As a result, the ends of the steel roof bar joists are severely rusted. The steel beam flange plates that extend from the top or bottom of the perimeter steel beams to support the parapet walls and the top portion of the masonry walls are also severely rusted.

Once the steel infrastructure was fully exposed, our structural engineer determined that the perimeter walls are not adequately gravity load bearing. While this structural design was fully code compliant in 1949 when the building was built, it is not compliant with today's building code with which we must comply. As a result, shear walls in the building's interior may be required to reinforce the perimeter walls and provide lateral stability for the building. This option will be assessed in conjunction with our evaluation of proposals from steel vendors to address the rust/deterioration problems described above.

All these structural issues must be addressed in our building renovation efforts, and have already adversely impacted project timing and construction cost estimates. Our Construction Manager and Owner's Representative have been evaluating alternative courses of action to address these structural issues and their impact on the project timeline and budget. The options range from repairing the existing steel infrastructure to partially or fully replacing it. This assessment has been ongoing and is expected to take another 4 to 8 weeks to complete.
